URGENT: Medical Device Recall Notification [Expansion of Affected Units]
AFFECTED DEVICE: Alaris™ Pump Module Model 8100

April 15, 2019

BD is announcing a recall expansion¹ of the Alaris™ Pump Module to include all bezels manufactured between April 2011 and June 2017. All of the bezels subject to this recall expansion were manufactured with a specific type of plastic, called FR-110.

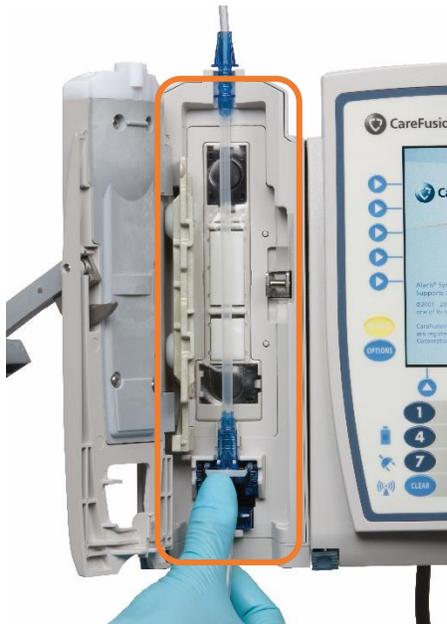
Figure 1a: Pump Module with door open showing the front of the bezel

The component of the Alaris Pump module that is the subject of this recall is the bezel assembly (*Attachment A, Figure 1*), and the issue involves potential separation of the bezel posts (*Attachment A, Figure 2*). The bezel has 6 posts that connect the pumping mechanism frame to the bezel assembly and are critical to proper performance of the pump. BD's ongoing investigation has determined that the bezel manufacturing process for the FR-110 plastic may have resulted in its weakening. A bezel with weakened plastic may, over time, lead to separation of the bezel post (recall issue) as well as other damage to the bezel (i.e. external cracking). The separation of one or more bezel posts is a potential safety concern and, therefore, BD is initiating this voluntary recall.

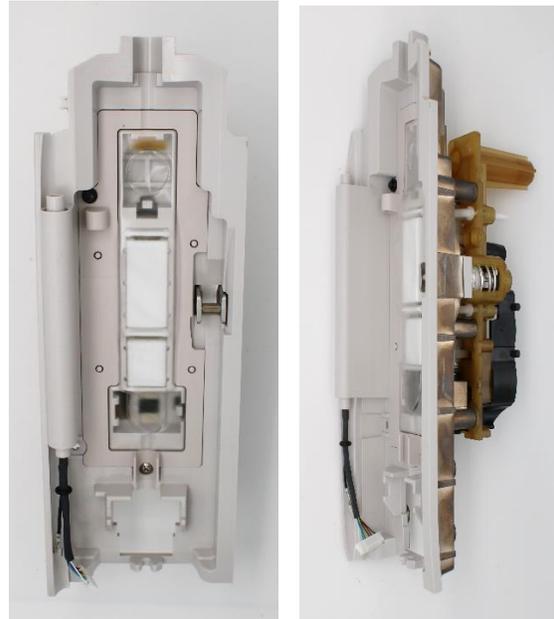
Figure 1b: Front and side views of the bezel assembly

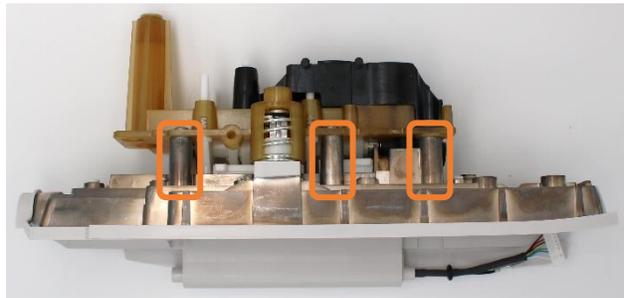
Figure 2a: Back side of bezel assembly highlighting the bezel posts

The separation of one or more bezel posts may result in free flow, over infusion, under infusion or interruption of infusion. To date, BD has received 364 reports of separated bezel posts with 12 resulting in injury reports without lasting harm or death.

Until the bezels affected by this recall are replaced by BD, customers should inspect bezels of both Priority 1 and Priority 2 pumps during their annual preventative maintenance schedule. Any pumps with bezel post separation should be removed from service.

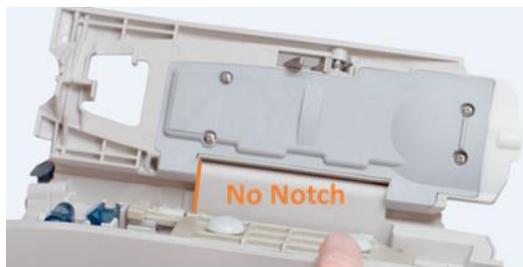
Figure 3: Side view of affected bezel, FR-110

1. See *Attachment A, Figures 3 and 4*, or Service Bulletin 621, to determine if you have installed a replacement Valox bezel. Refer to *Attachment E* for the quantity of unaffected Valox replacement bezels shipped to your facility.
2. Mark unaffected pumps for easy identification.
3. Notify BD of Alaris™ Pump Modules that have had Valox replacement bezels installed. Instructions are available at <http://alaris.bdproductnotice.com>.

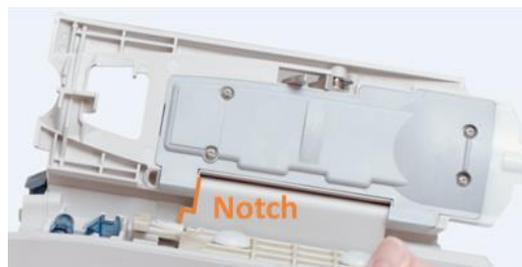
Figure 4: Side view of non-affected bezel, Valox

The recall DOES NOT include Alaris™ Pump Modules or bezel replacement kits (P/N 49000270 or P/N 49000269) manufactured after June 2017. Beginning in June 2017, BD began making bezels with a different plastic material called Valox. Valox bezels have been tested extensively by BD to ensure reliability. There have been no patient injuries or complaints of cracking associated with Valox bezels to date.
